CULTURAL RESOURCE IDENTIFICATION SURVEY FOR THE CONGAREE RIVER SEDIMENT REMOVAL PROJECT

RICHLAND COUNTY, SOUTH CAROLINA

Final Report

**ARCHAEOLOGICAL DATA RECOVERY PLAN FOR THE
MITIGATION OF SITE 38RD286/38RD278, THE ORDNANCE
DUMP SITE, FOR THE CONGAREE RIVER SEDIMENT
REMOVAL PROJECT, COLUMBIA, SOUTH CAROLINA**

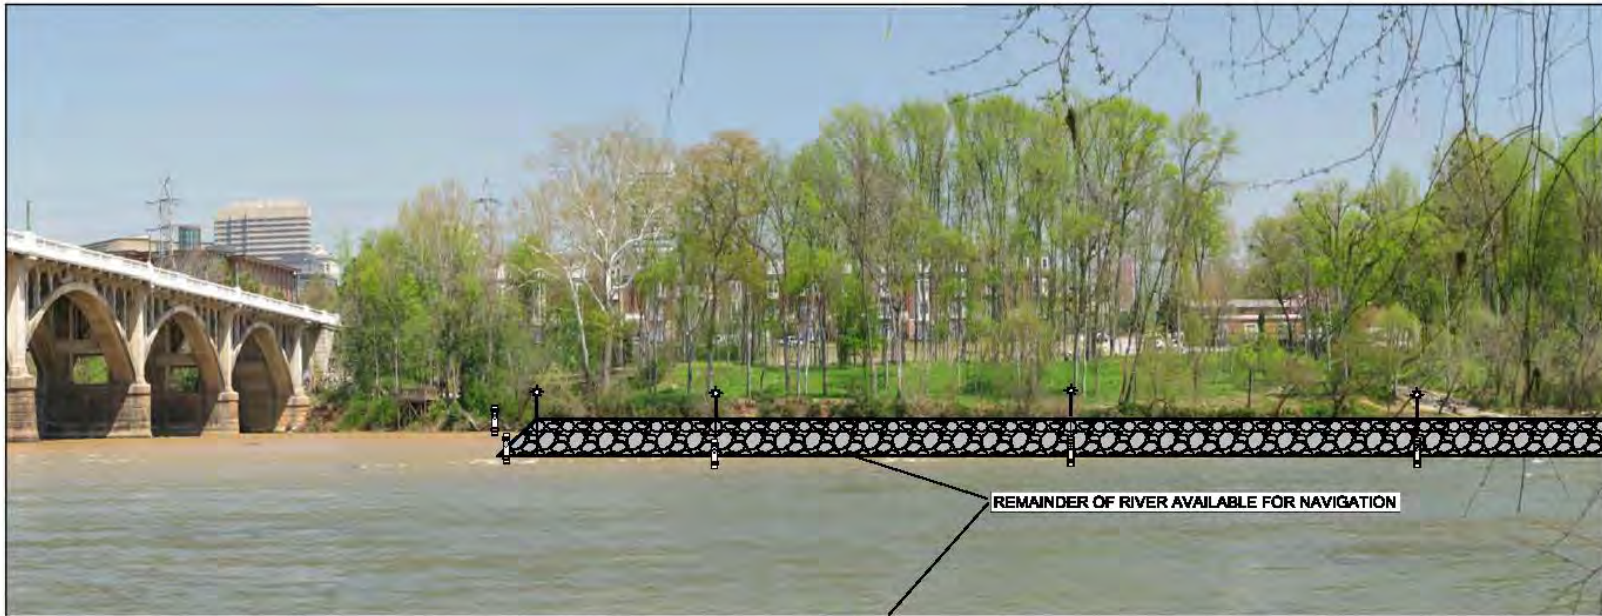
- DRAWING NOT TO SCALE AND IS FOR ILLUSTRATIVE PURPOSES ONLY.
- COFFERDAM STRUCTURE LOCATION AND CONFIGURATION IS APPROXIMATE.
- PHOTOGRAPH TAKEN FROM THE WEST BANK OF THE RIVER LOOKING EAST.

The first component of the sediment removal will be the construction of a cofferdam around the planned removal areas. The purpose of the coffer dam is to isolate and dewater the areas prior to initiating the removal operations. The coffer dam will be designed to be over-topped during high water events. At average water levels the dam will rise approximately eight feet above the waterline. The temporary dam will be constructed with an impermeable barrier covered by stone or rip rap. Figure 4 is a conceptual rendering showing the approximate height and attributes of the coffer dam.

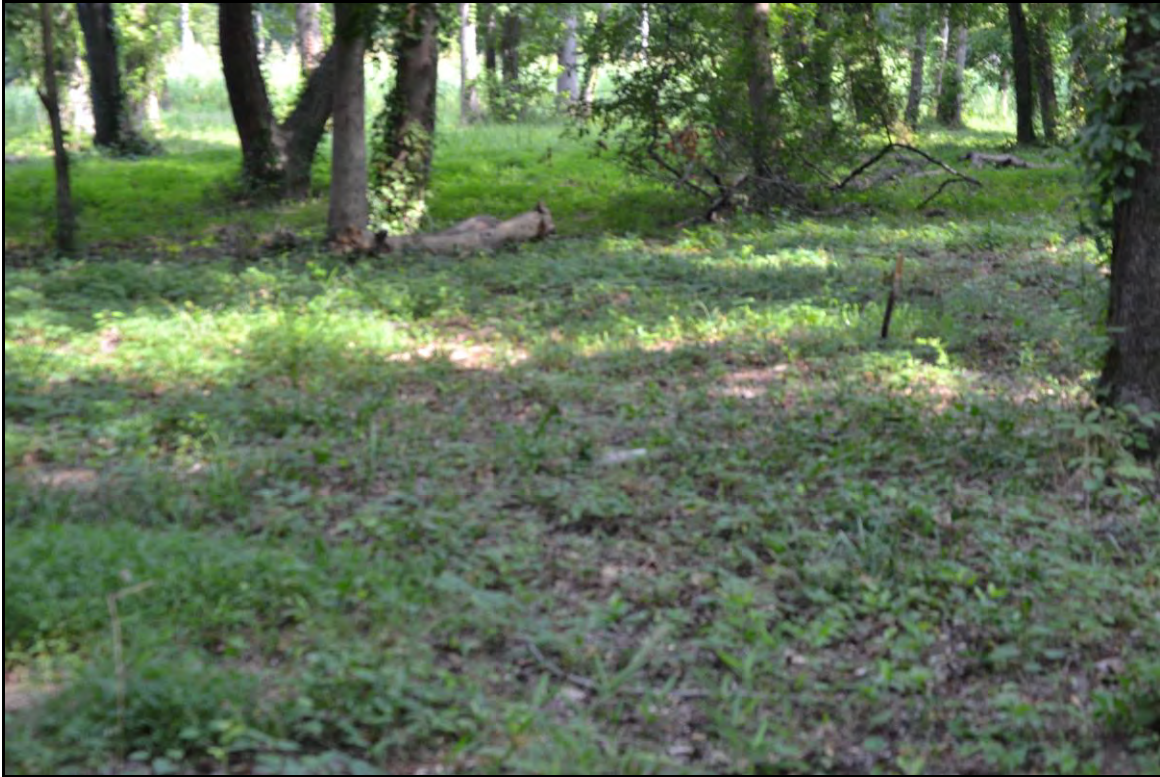
Figure 11. Conditions at 38RD224.

This site was visited and an attempt to locate the foundation and any historic artifacts visible on the ground surface. A picture of the foundation shows stacked, large granite blocks. Transects

separated by a 15 meter interval were walked in the mapped location of the site. Vegetation consisted of manicured grass in the upland portion of the site and shin high grasses and undergrowth closer to the river's edge (Figure 11). No trace of an intact granite foundation was found. While accessing the site via the City of Columbia River Walk large granite blocks were noted lining the pathway and marking drainage areas (Figure 12). These blocks are presumed to be the foundation stones identified in 1981 now repurposed as decorative elements to the river walk.

38RD224 – In 1981 Canouts and Harmon located a building foundation approximately 60 meters downstream of a small unnamed tributary of the Congaree River (Figure 10). The ruins were noted as being in good condition and were assumed to be the remains of Briggs sawmill, a mill utilized by the Confederate government and burned by Union Troops in 1865. The site was considered significant and recommended for additional work.

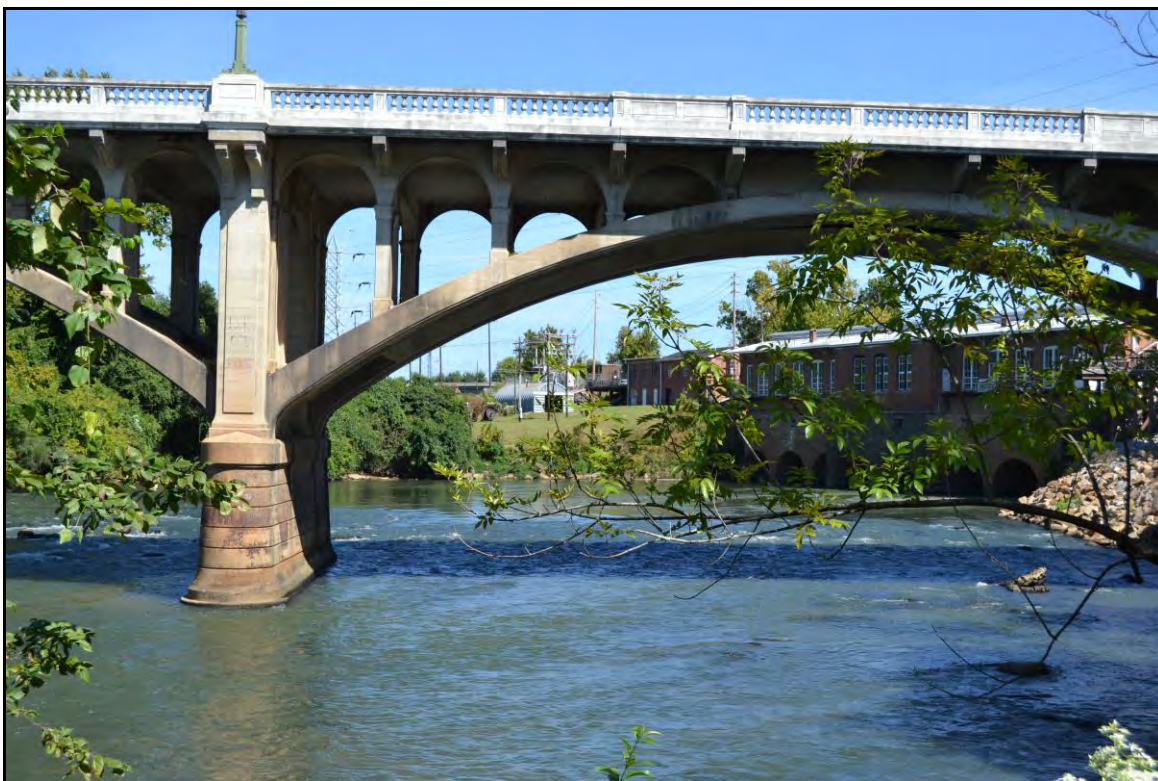
Figure 22. View from project location to Canal Hydro Plant, facing north.

The Hydro Plant was built in 1896. It furnished electricity for lights in the city of Columbia, as well as supplied current for public and private manufacturing and the Street Railway System. The plant is still operational and provides a large portion of power for the city. While the internal workings of the Hydro Plant have been updated and modified to meet today's demand for electricity the building itself remains much as it was when it was first built. It is a brick

structure with symmetrical arches that allow the canal to flow back into the river. The plant can be seen from the northern edge of the project area (Figure 22).

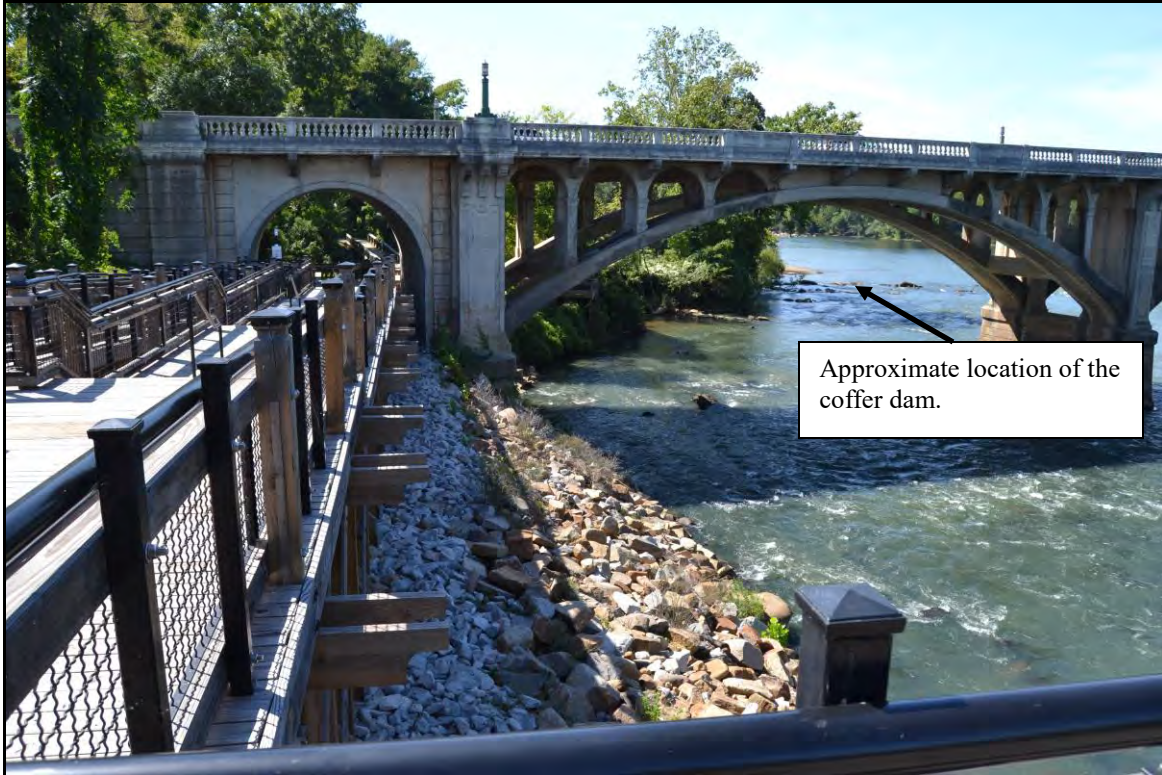
Figure 23. View from Columbia Canal Hydro Plant to project area. Note rip rap.

The temporary coffer dam will be similar in appearance to the existing rip rap and stone embankment that currently abuts the Hydro Plant (Figure 23). The coffer dam will in fact be similar in construction to the canal itself. Canouts and Harmon (1981) note that an 1867 profile drawing shows the canal banks as rip rap along the river's edge. They also indicate that the 1891 canal had rip rap placed along erosional areas. Additionally there are numerous modern intrusions to the Hydro Plant's viewshed. The Edventure Children's Museum with its modern three story glass façade is adjacent to the plant compromising the historic integrity of Canal District (Figure 24). The proposed project will have no impact on the visual landscape of the Columbia Canal Historic District.

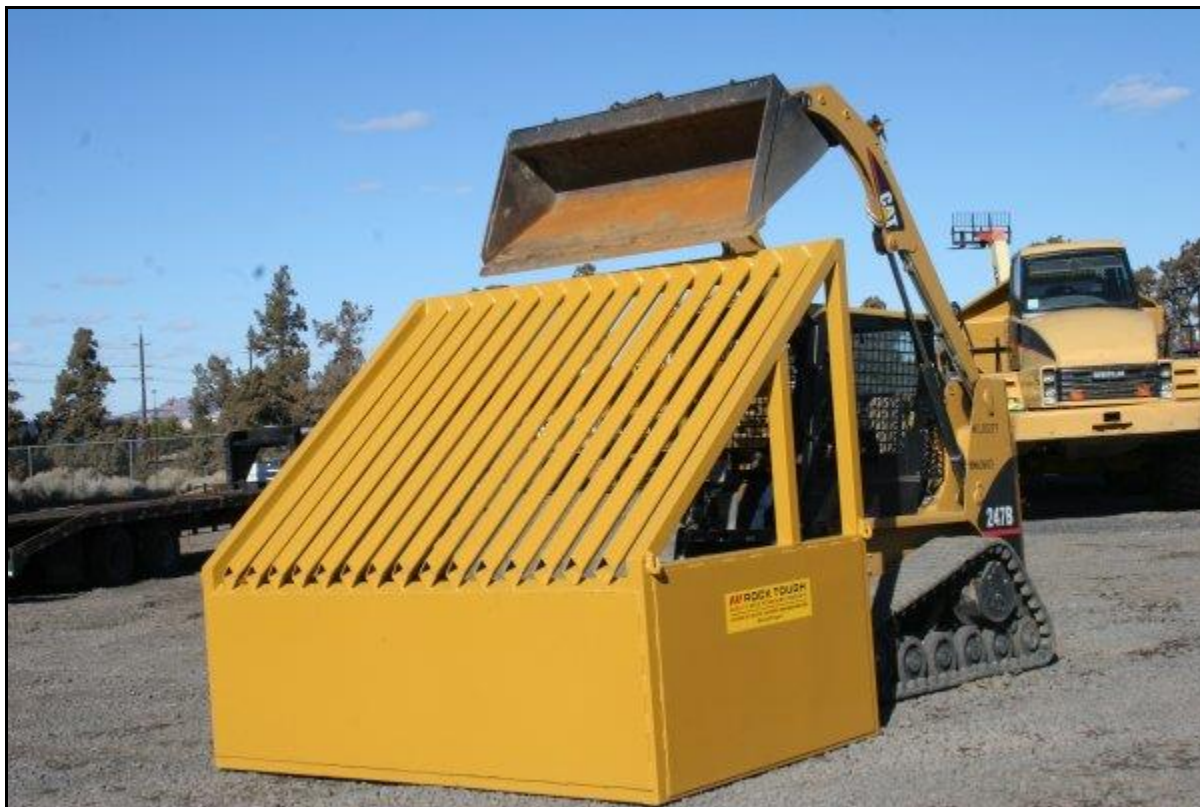
Figure 6. Example of a bar sorter

produces may necessitate the need for an off-site processing location. The Columbia landfill has tentatively been identified as the off-site recovery location. The examination of contaminated soil will take place visually and through geophysical methods.

When it arrives at the off-site facility the soil will once again be stored according to grid location. An area measuring up to 50 feet by 50 feet (final dimensions will depend on the amount of open land available) will be covered with heavy, industrial plastic sheeting. A backhoe will be used to spread the sediment from a selected grid square in a thin layer, up to 2 inches thick, on the sheeting. Five-foot-wide lanes will be established across the examination area. A crew of archaeological field technicians will then walk the lanes and make a visual survey of the sediment collecting artifacts as they are encountered.
