PROJECT DESIGN AND RELATED INFORMATION

APPENDIX A

RE: Removal Action Alternative
SCE&G Fleet Maintenance Site (Congaree River)
Columbia, South Carolina

RE: Preliminary Removal Action Work Plan
SCE&G Fleet Maintenance Site (Congaree River)
Columbia, South Carolina

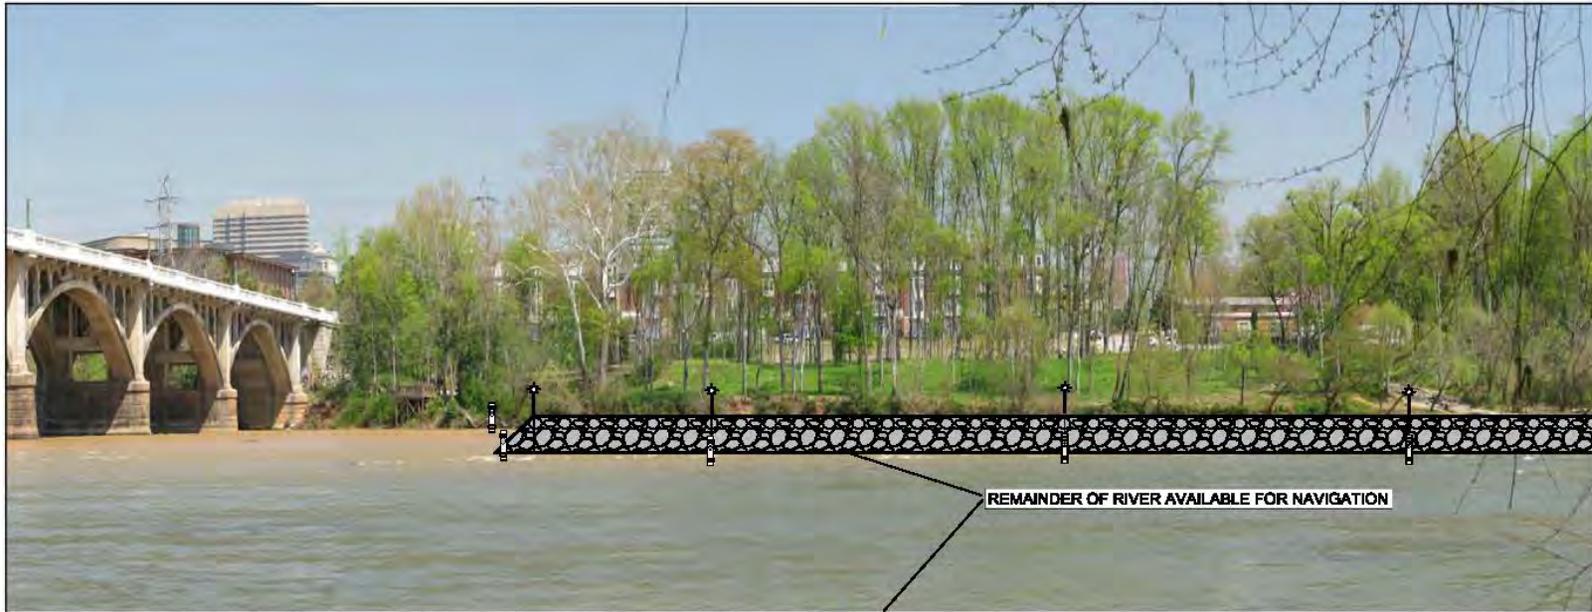
Figure 3. Conceptual construction plan for proposed access roads and improvements.

The first component of the sediment removal will be the construction of a cofferdam around the planned removal areas. The purpose of the coffer dam is to isolate and dewater the areas prior to initiating the removal operations. The coffer dam will be designed to be over-topped during high water events. At average water levels the dam will rise approximately eight feet above the waterline. The temporary dam will be constructed with an impermeable barrier covered by stone or rip rap. Figure 4 is a conceptual rendering showing the approximate height and attributes of the coffer dam.

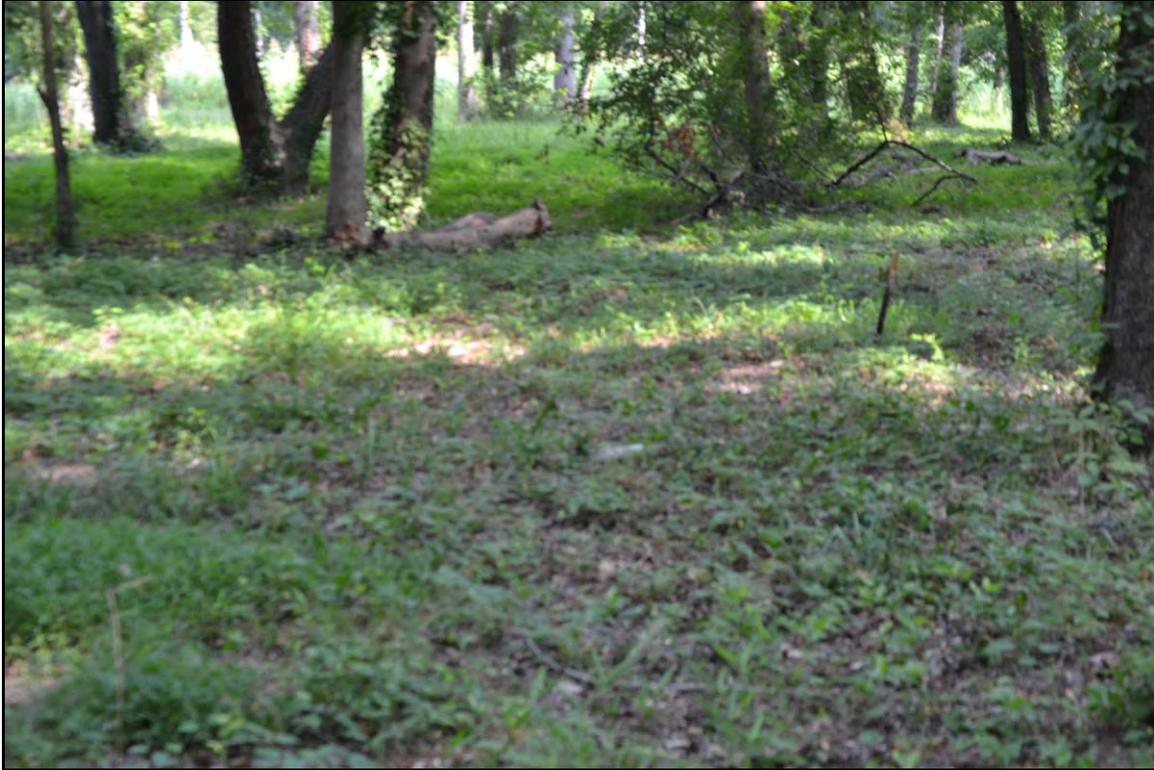
Figure 11. Conditions at 38RD224.

separated by a 15 meter interval were walked in the mapped location of the site. Vegetation consisted of manicured grass in the upland portion of the site and shin high grasses and undergrowth closer to the river's edge (Figure 11). No trace of an intact granite foundation was found. While accessing the site via the City of Columbia River Walk large granite blocks were noted lining the pathway and marking drainage areas (Figure 12). These blocks are presumed to be the foundation stones identified in 1981 now repurposed as decorative elements to the river walk.

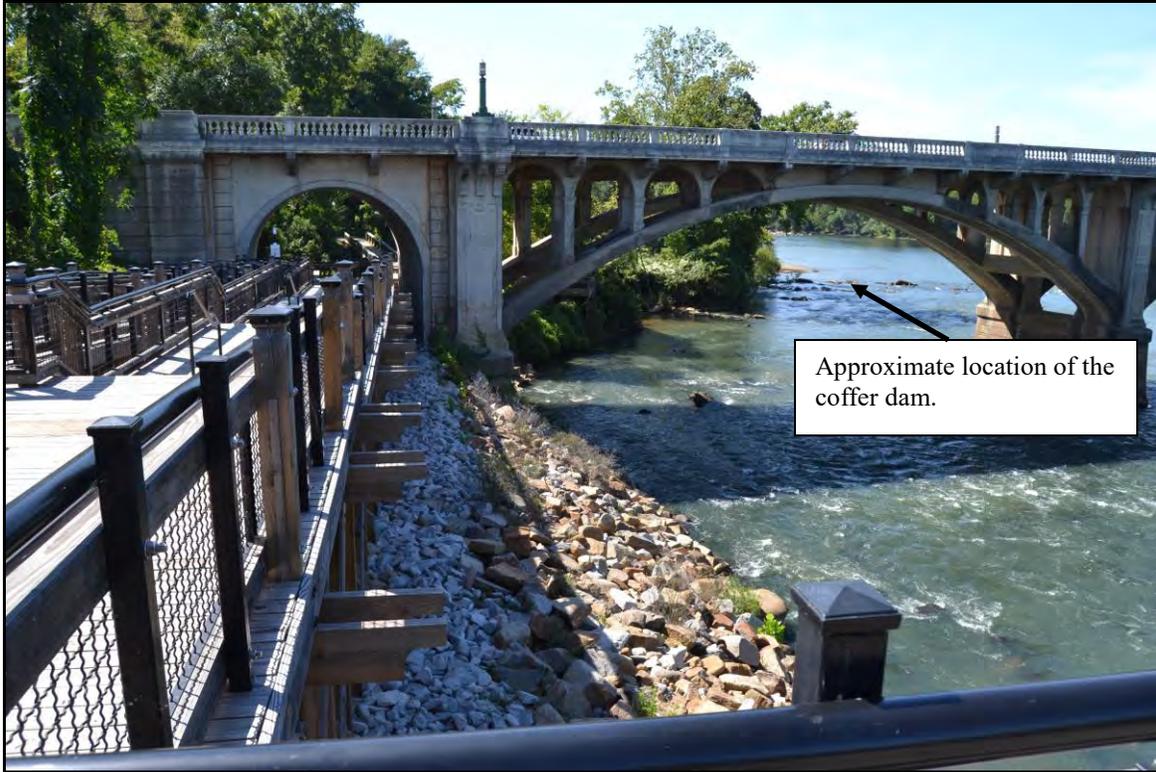
Figure 23. View from Columbia Canal Hydro Plant to project area. Note rip rap.

The temporary coffer dam will be similar in appearance to the existing rip rap and stone embankment that currently abuts the Hydro Plant (Figure 23). The coffer dam will in fact be similar in construction to the canal itself. Canouts and Harmon (1981) note that an 1867 profile drawing shows the canal banks as rip rap along the river's edge. They also indicate that the 1891 canal had rip rap placed along erosional areas. Additionally there are numerous modern intrusions to the Hydro Plant's viewshed. The Edventure Children's Museum with its modern three story glass façade is adjacent to the plant compromising the historic integrity of Canal District (Figure 24). The proposed project will have no impact on the visual landscape of the Columbia Canal Historic District.

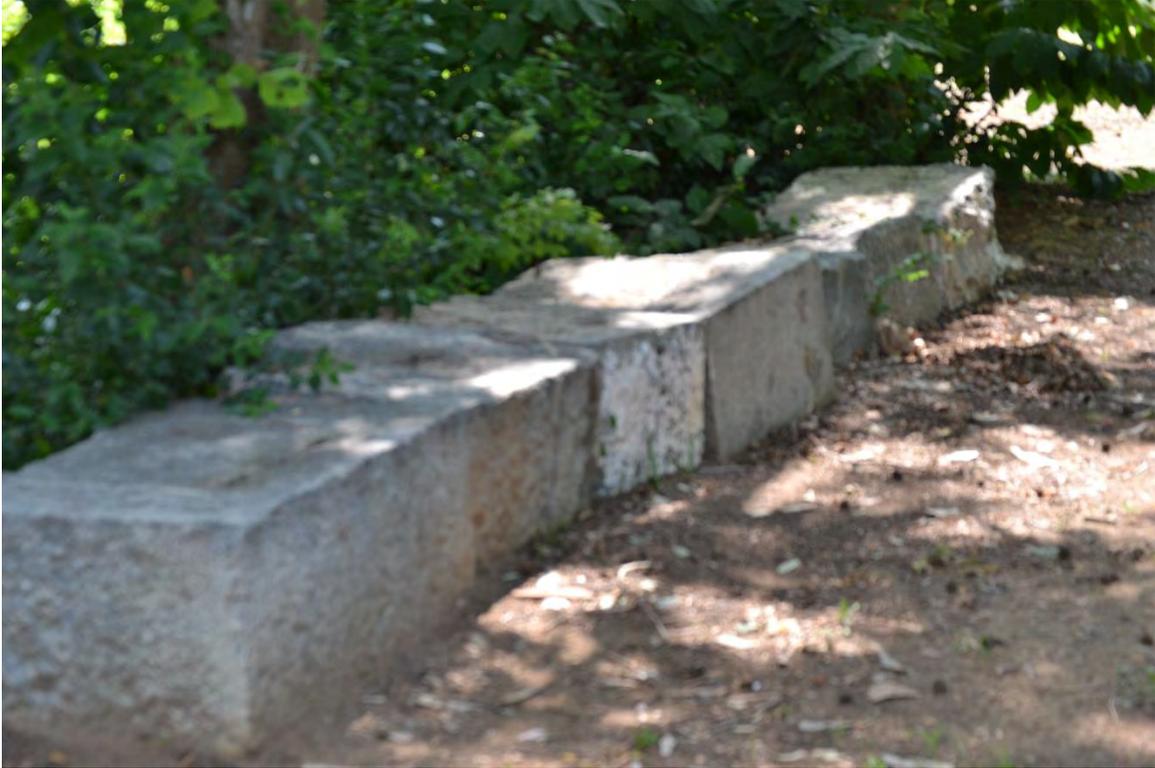
Figure 1. Historic granite blocks used as greenway border.

The Site was visited in 2014 (Norris 2014) in an attempt to locate the foundation and any historic artifacts visible on the ground surface.). No trace of an intact granite foundation was found. While accessing the site via the City of Columbia Riverwalk large granite blocks were noted lining the pathway and marking drainage areas (Figure 1). Based on information provided by the landowner, these blocks are not from the sawmill. Rather, they are blocks salvaged from the demolished Central Correction Institute and were placed in their current location by the City of Columbia to reduce erosion from the greenway.

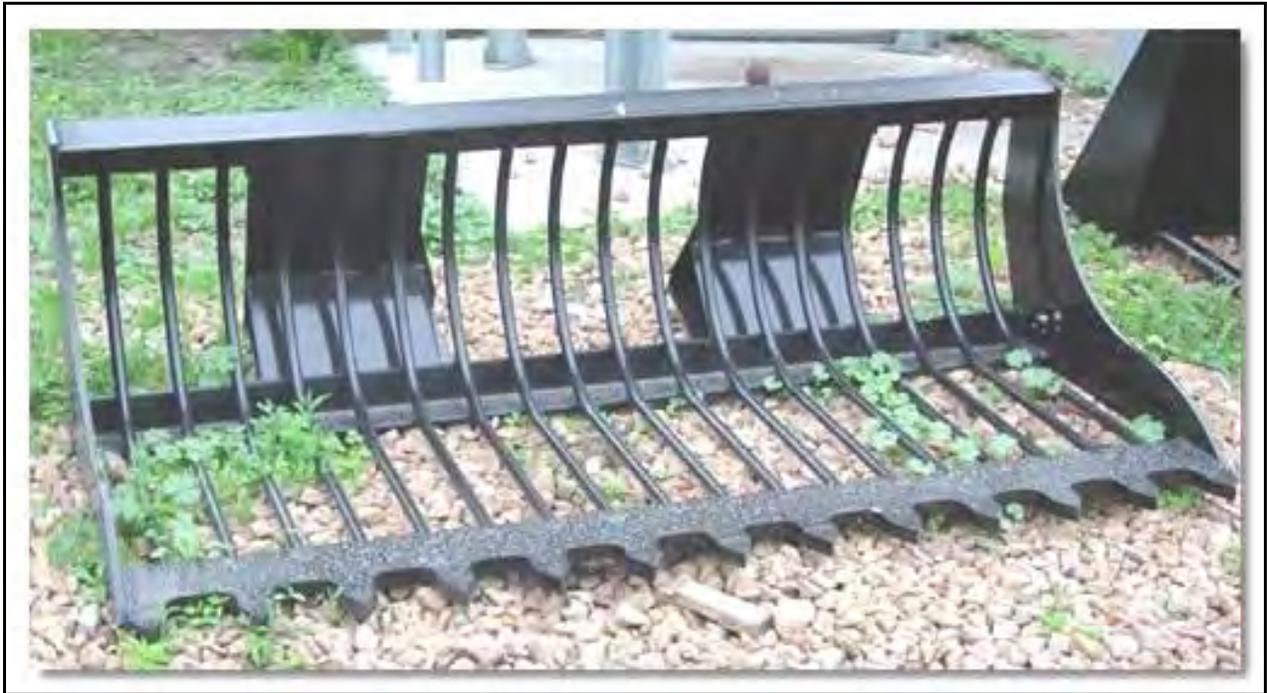
Figure 6. Example of a rock bucket to sort larger artifacts and sort rocks and debris.

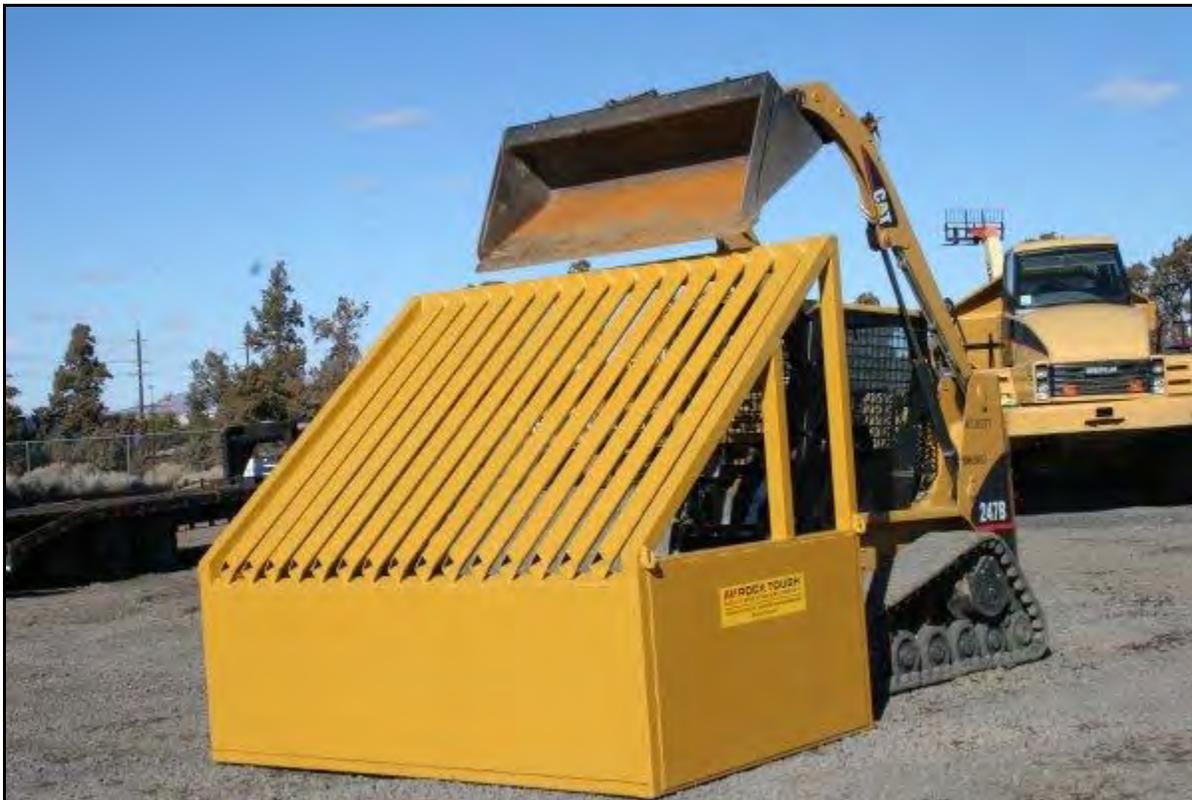
Figure 7. Example of a bar sorter
