Gills Creek Watershed: Assessment of Regulated Dams

February 15, 2016

PROJECT NAME: Gills Creek Watershed Assessment of Regulated Dams Report

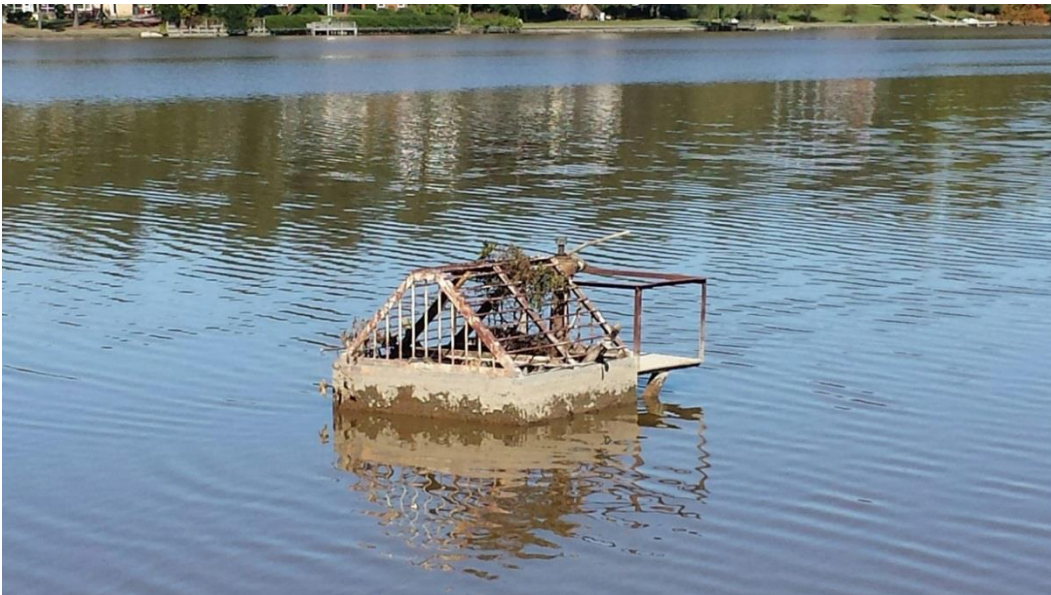
Photo 4: Service spillway concrete riser intake upstream of concrete/rockfill spillway

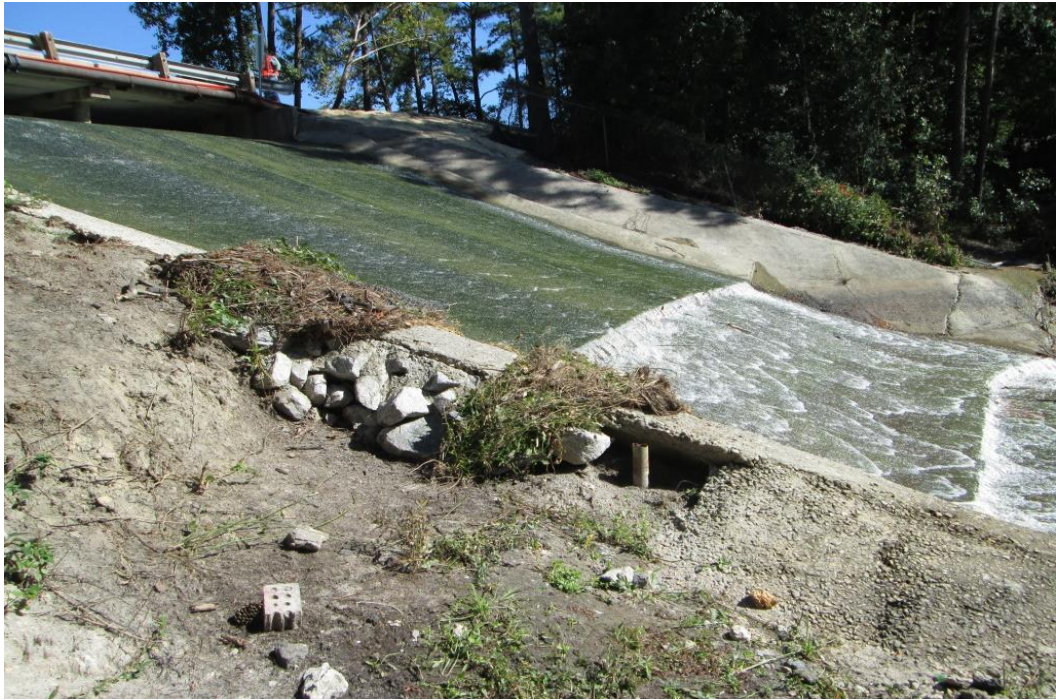
Photo 6: Eroded/filled areas along right side of auxiliary spillway channel

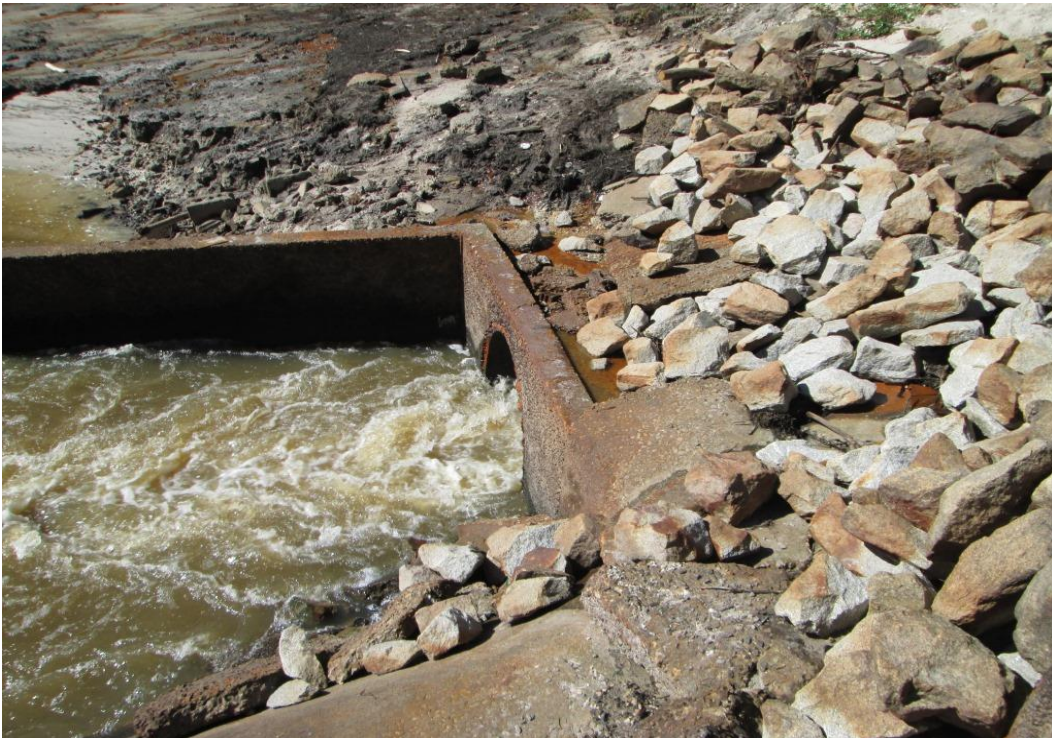
The service spillway is a low-level outlet (48-in. RCP) controlled by a concrete drop inlet located approximately 60 feet upstream of the dam. The inlet has a trash screen that appeared relatively free of debris (Photo 9). The outlet discharge is located to the right of the auxiliary spillway (Photo 10). Standing water with red coloration was observed at the headwall of the outlet structure, indicating potential seepage.

Photo 10: Low-level outlet structure; note discolored water just above the headwall

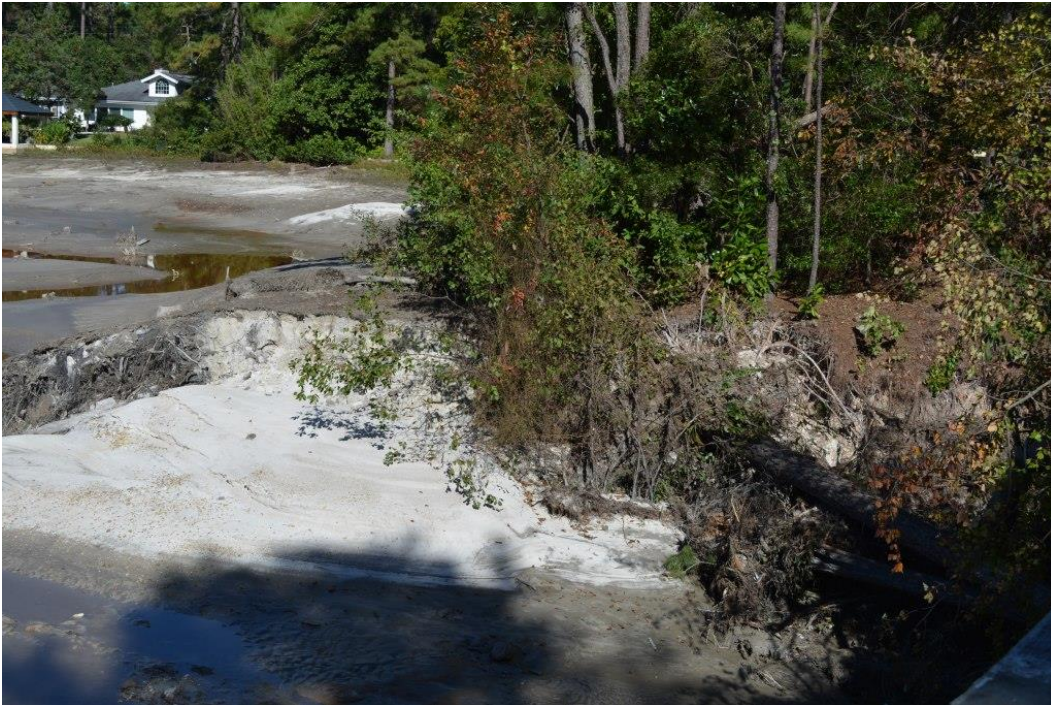
Photo 2: Erosion along the left side of approach channel to the auxiliary spillway

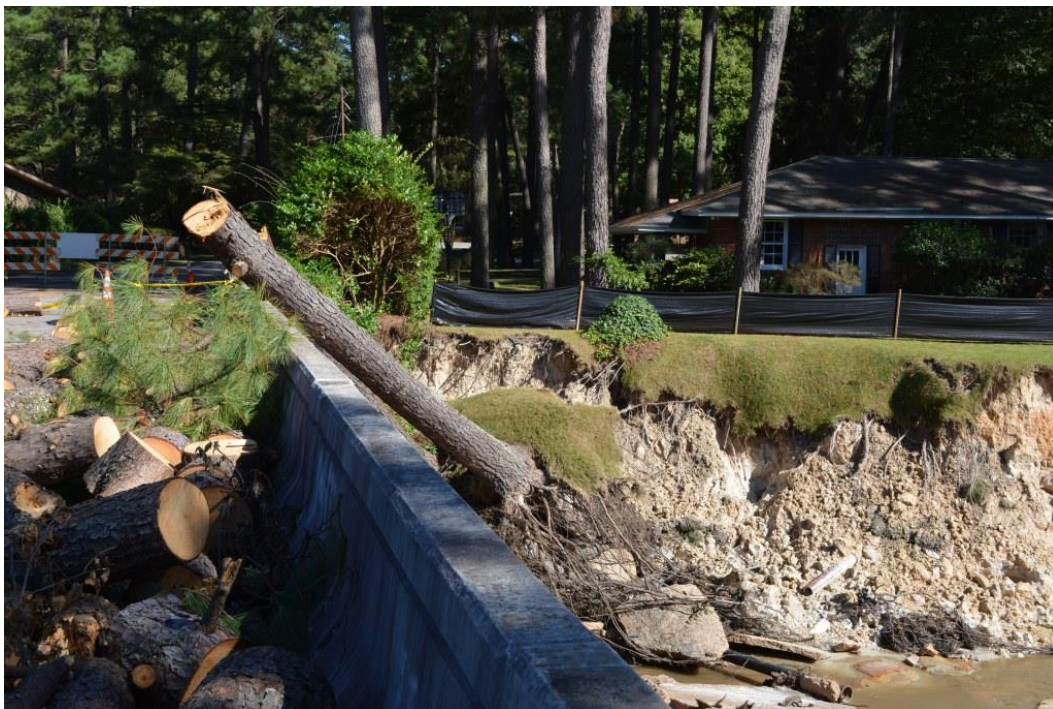
Photo 4: Erosion at the left abutment viewed from the bridge

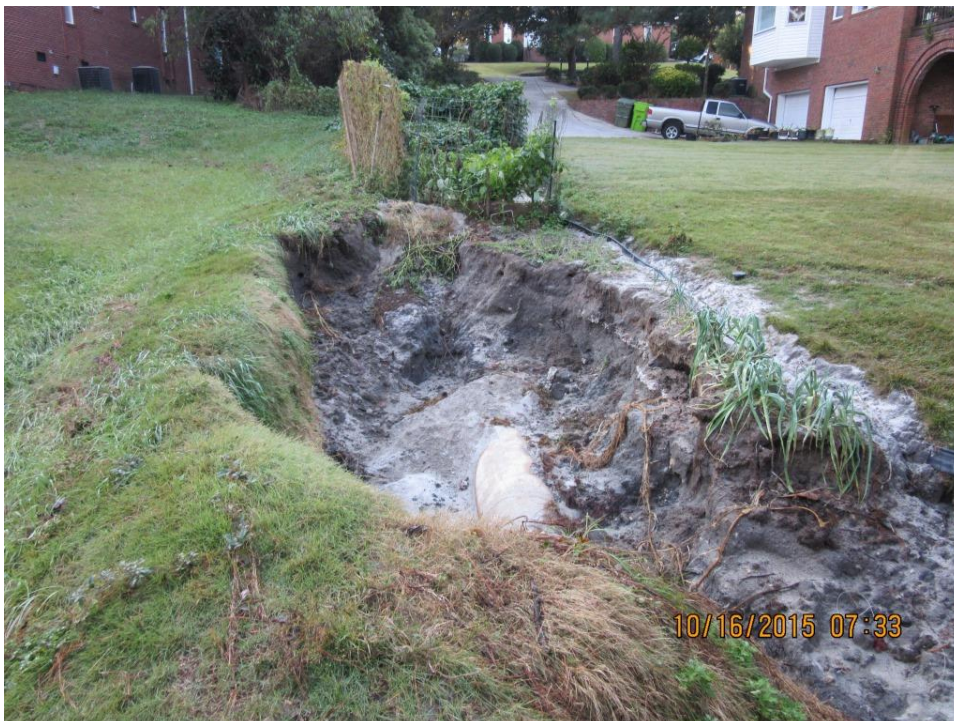
The auxiliary spillway is an earthen-grassed, uncontrolled, overflow channel located at the left abutment. It has a crest length of approximately 80 feet and conveys flow about 200 feet to the stream. Overtopping of the spillway during the flood event to a depth of 1 to 2 feet was evident. The spillway appeared to generally be in good condition (Photo 8) with some minor surficial erosion. Water was observed to be emerging at a location on the downstream slope of the auxiliary spillway about 100 feet downstream from the pond, approximately 5 feet below pond level (Photo 9). This seepage appears to be indication of piping of subsurface red clay material through the auxiliary spillway. A significant erosion channel was developed in the downstream area of the auxiliary spillway which exposed what appears to be a stormwater main (Photo 10).

Photo 10: Eroded area at downstream end of auxiliary exposing RCP pipe, presumably a stormwater main

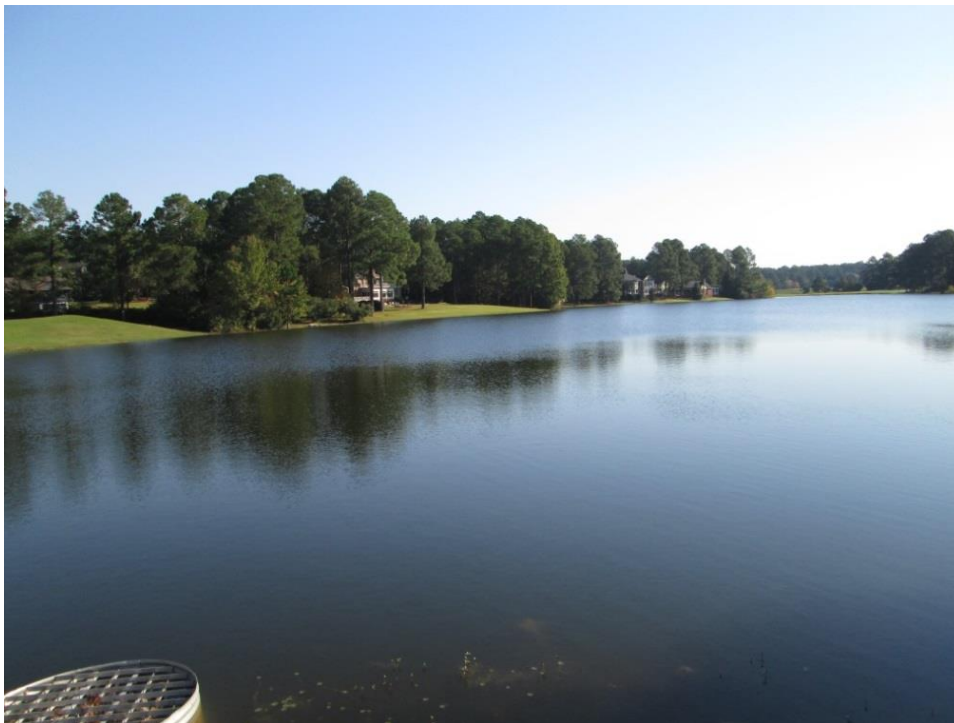
The service spillway is a low-level, 30-inch CMP pipe with drop inlet equipped with a trash screen. The inlet (Photo 4) and outlet pipe (Photo 5) appeared to be in good condition. No debris was observed on the inlet trash screen.

Photo 4: View of pond with service spillway drop inlet in foreground
