LAKE CONESTEE DAM EVALUATION OF ALTERNATIVES REPORT

**The Conestee Foundation, Inc.
Greenville, South Carolina**

Kleinschmidt

Project 2001002
October 2019

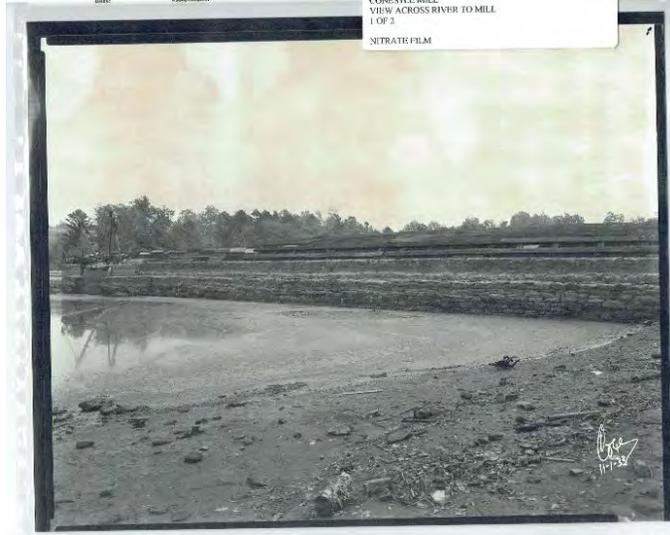
FIGURE 1 UPSTREAM FACE OF LAKE CONESTEE DAM

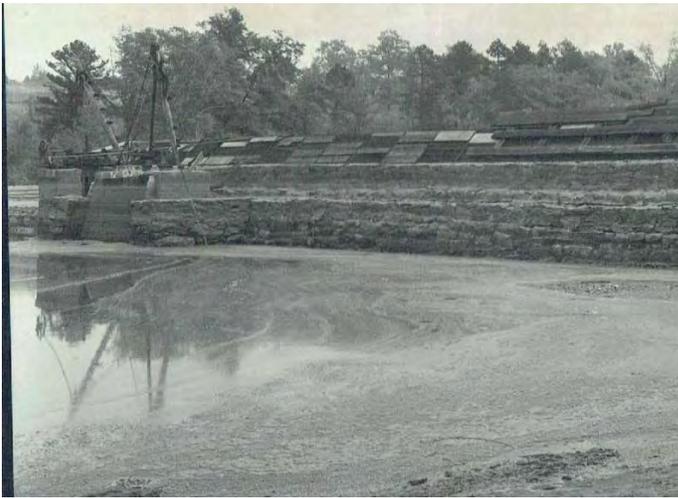
FIGURE 2 UPSTREAM FACE OF LAKE CONESTEE DAM

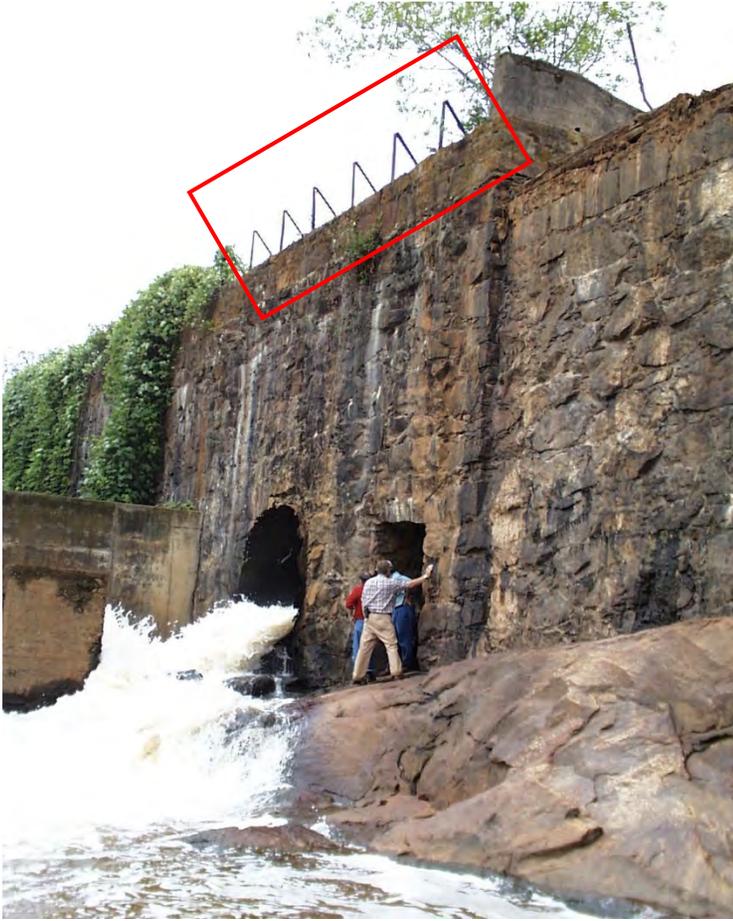
Photo 4.3: 2001. Note flashboard steel support frames.

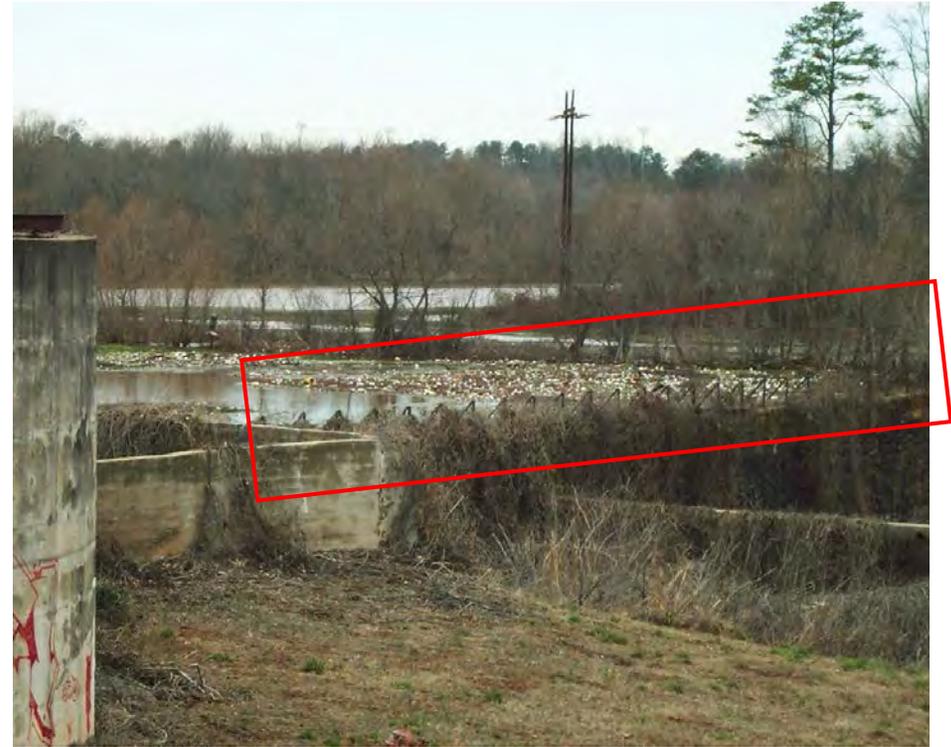
Photo 4.4: 2002. Note flashboard steel support frames.

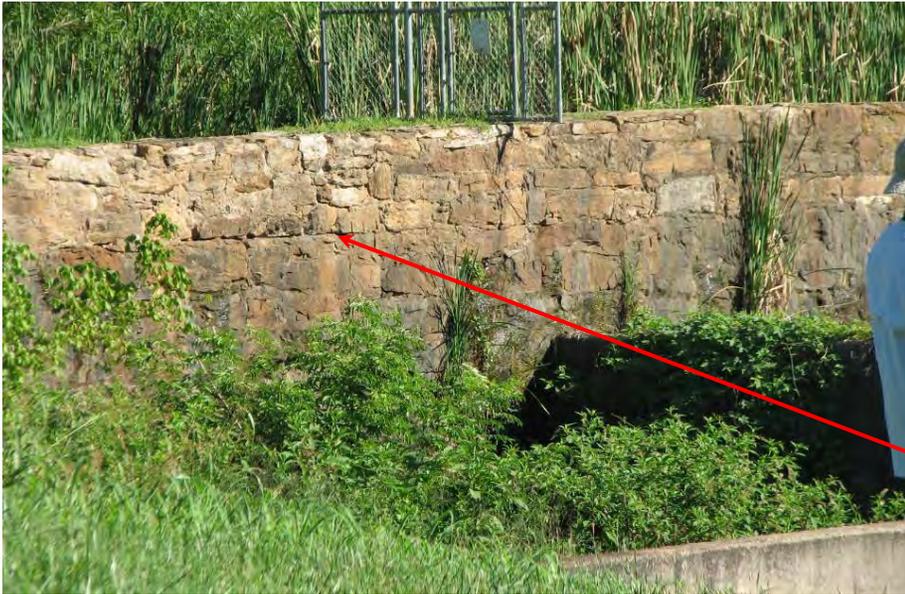
At some point in time the crest of the non-overflow structures and spillway were raised approximately 3 feet as indicated by horizontal lift joints in the masonry (Photos 5, 6, 25, and 4.1 &

Photo 5: Right Non-Overflow; downstream side middle third.

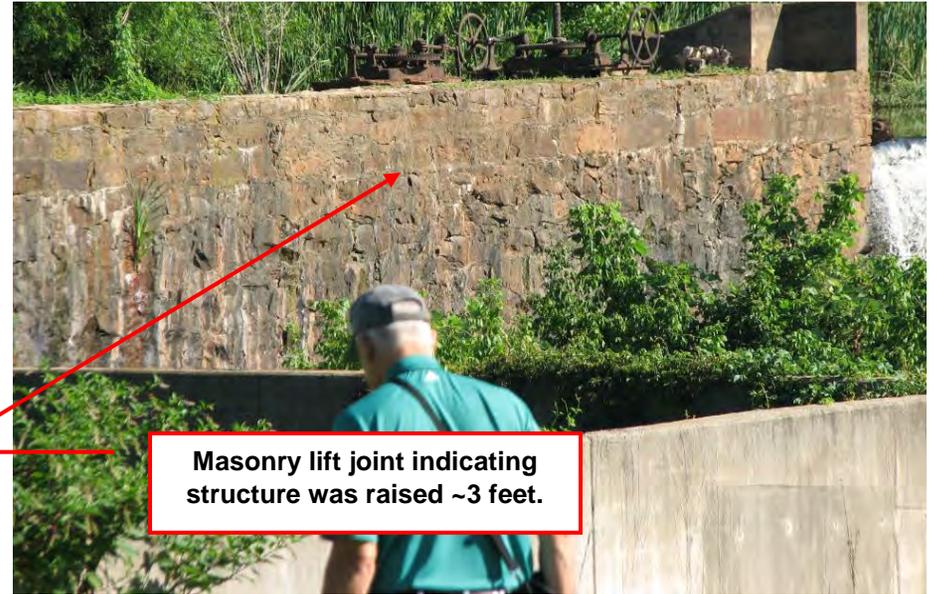
Photo 6: Right Non-Overflow; downstream side left third.

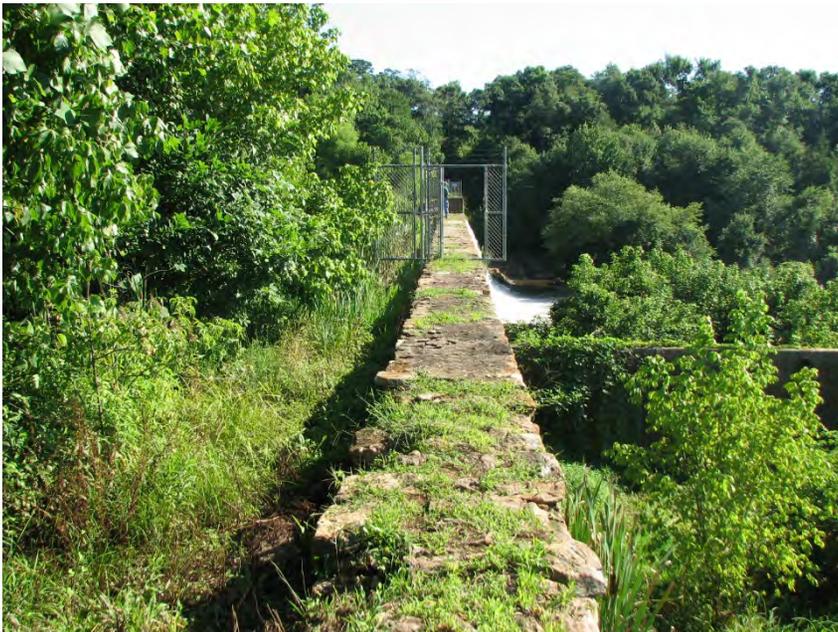
Photo 7: 4 ft wide Right Non-Overflow, crest looking left.

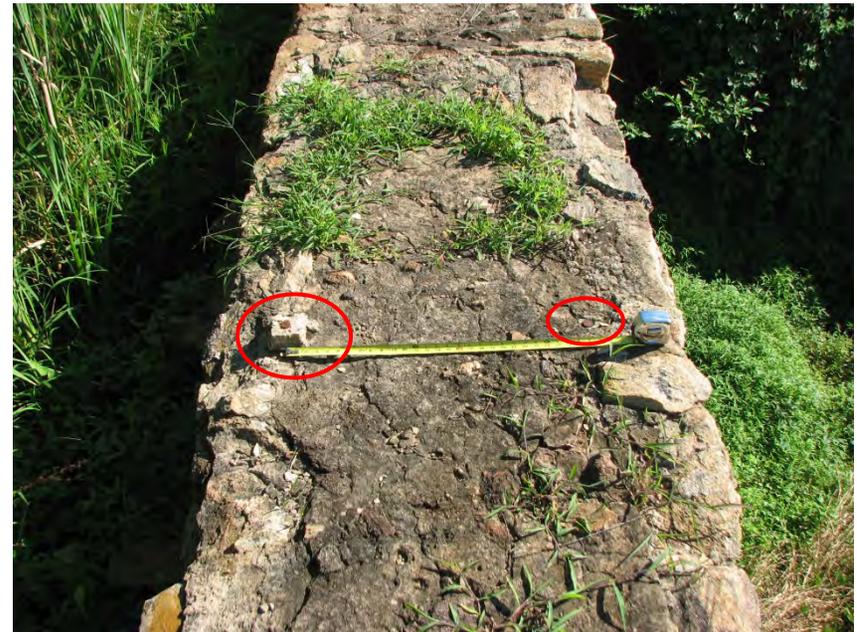
Based on visual observations, the structure appeared to be true to alignment and elevation exhibiting no signs of movement or structural distress. No displacement or bulging of stone masonry blocks was observed other than along the crest of the structure (Photo 8) where displaced or missing small stone has occurred as would be expected as a result of thermal movements and possible minor freeze thaw action occurring over 100 years. There was no structural cracking observed, nor cracking that would be associated with movement.

Photo 8: Right Non-Overflow, crest. Flashboard support frame anchors are circled; 2'-4" apart and spaced at 5'-3".

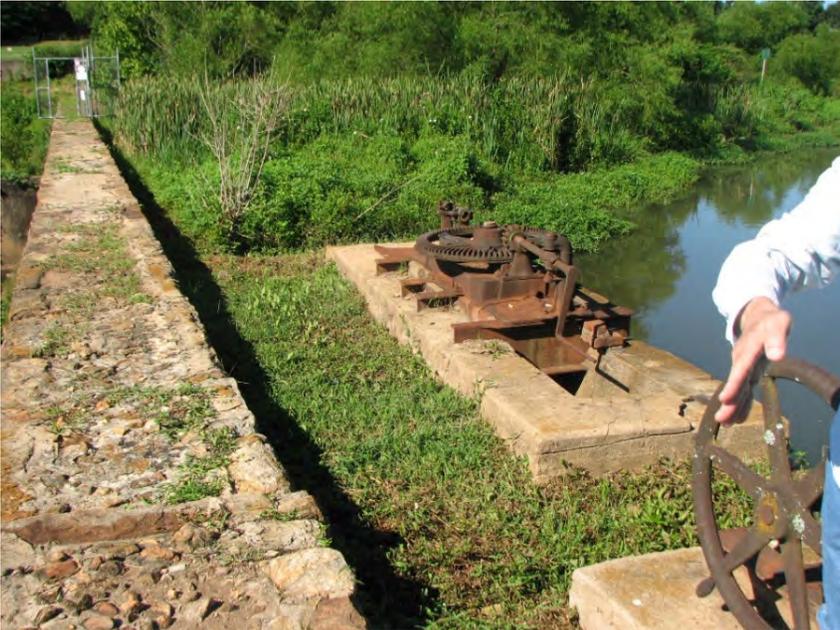
At the left end of the RNO is an outlet structure that used to connect to a penstock that extended to the mill downstream; the outlet structure also used to have a sluice gate (Photos 9 and 10). The penstock has collapsed and has been cut away (Photo 11) and the sluice gate opening was plugged with concrete in 2002 (Photo 12). A wood bulkhead was installed in 2001 on the upstream side of the penstock intake (Photo 13.1). The bulkhead is not operational as it is not connected to an operator. The bulkhead can be removed only with a crane after connecting to the lifting cables that are attached to the top of the bulkhead. Leakage from the bulkhead was reported to be intentional in order to assure some flow is being released from the dam but based on the condition of the timber seals around the penstock opening as seen on 2002 (Photo 13.1), it is the opinion of the undersigned that the current volume of leakage could be the result of erosion of the deteriorated timber seals.

Photo 9: Right Non-Overflow, crest looking right at outlet structure.

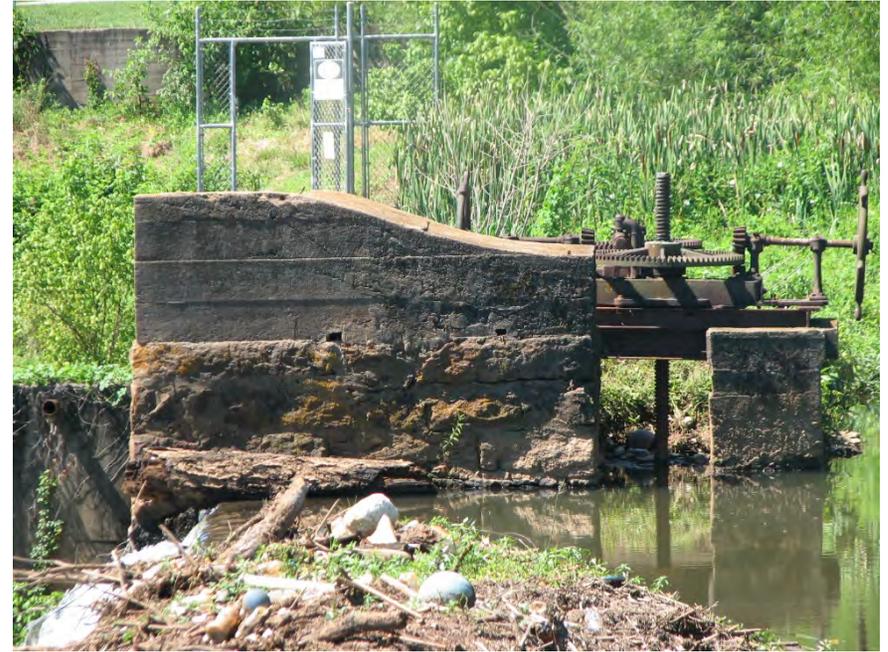
Photo 13: Outlet structure as seen from left side of spillway dam.

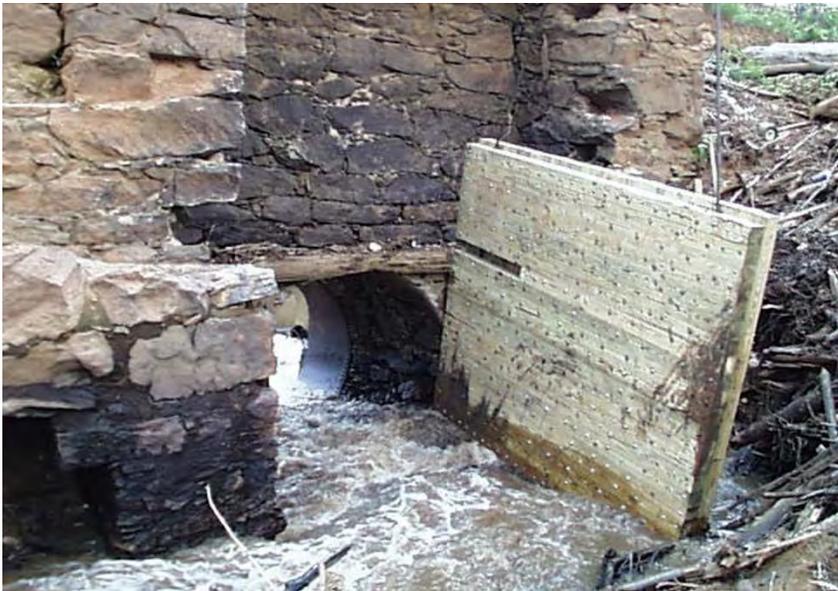
Photo13.1: June 2001, wood bulkhead installed on upstream side of intake to penstock.

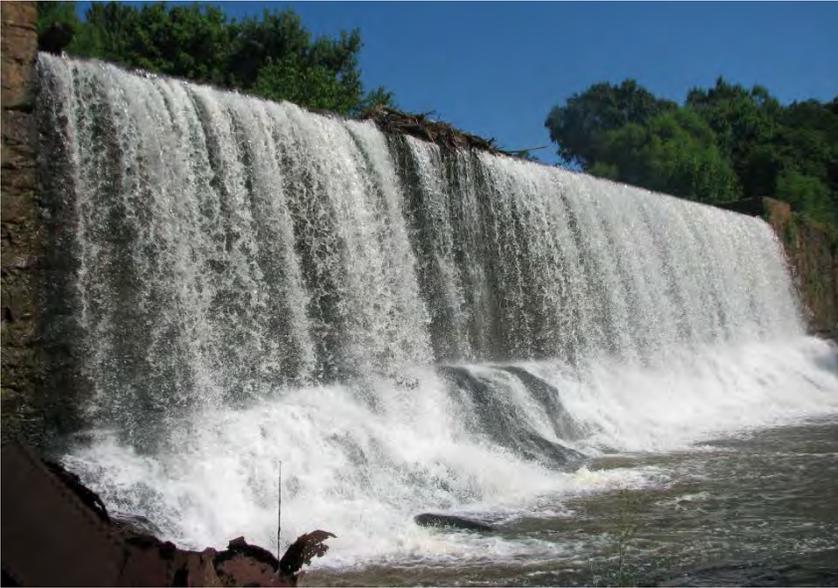
The “low crest” is 12-inches below the “high crest”. At the time of the inspection there was approximately 4-inches of water passing over the low crest section of the spillway dam and the condition of the structure could not be seen (Photos 14, 16, and 17). Based on the shape of the discharge over the crest (Photos 16 and 17) it appears that the crest is intact and without any loss or displacement of the concrete cap. As could be discerned from Photo 15, there does not appear to be any stone masonry blocks missing from the face of the low crest section of the spillway. The extent and volume of seepage from the low crest section of the spillway could not be determined.

Photo 14: Spillway dam, low crest section.

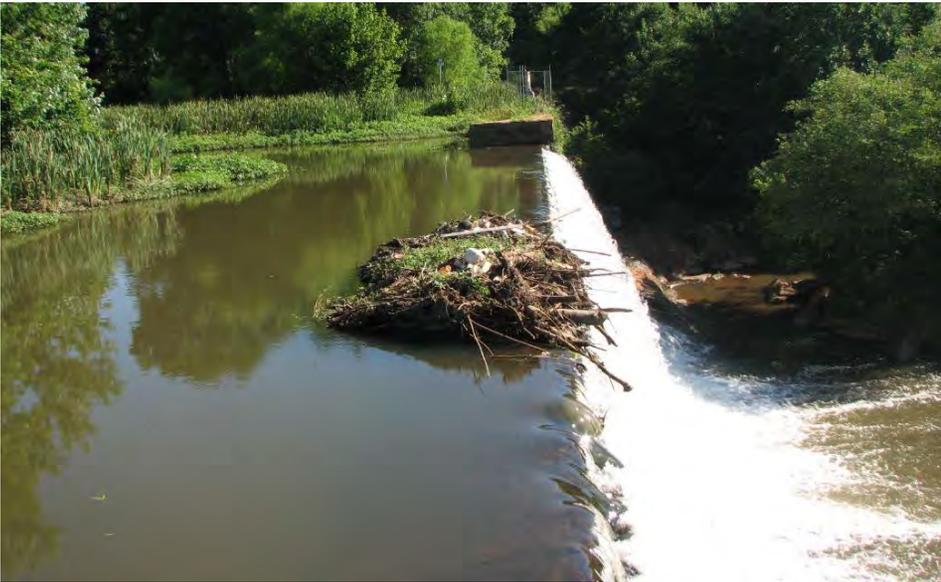
There was a minimal amount of debris accumulation on the low spillway crest (Photo 16). It was reported that any heavy accumulation of large wood debris is periodically removed in compliance with the requirements of the Covenant. Based on the shape of the discharge over the crest it does not appear that debris has damaged or displaced any of the crest’s capping concrete. Debris accumulation in the river channel downstream of the dam is also minimal; due to the height of the dam, it is improbable that debris accumulation in the river downstream of the dam could ever be significant enough to impact the stability or discharge capacity of the dam.

Photo 16: Spillway dam, low crest section looking left.

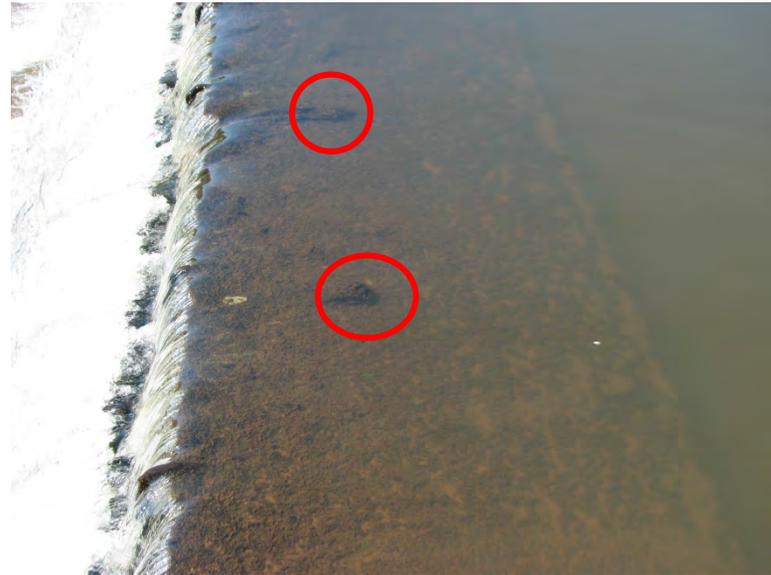
Photo 17: Spillway dam, low crest section looking right. Note remains of flashboard pins/anchors.

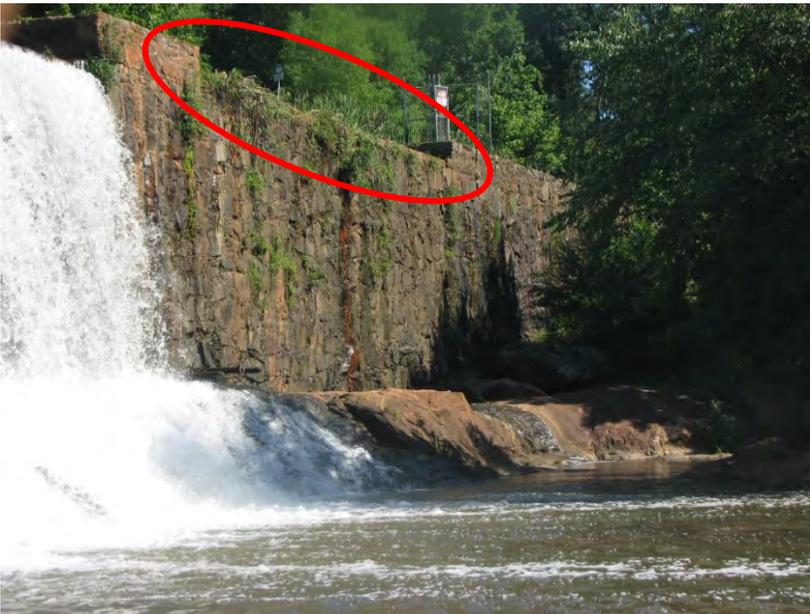
The high crest section of the spillway appears to be in good condition (Photos 20 through 25). There is some leakage, but not great in volume nor being discharged under pressure, through the masonry approximately 3 feet below the spillway crest (Photos 20 and 21). The base of the spillway is founded on exposed bedrock and there was no seepage observed to be occurring along the base of the spillway. There was vegetation growing on the face of the structure; it was reported that herbicides are applied annually to control vegetation. Mortar joints are tight and are generally in good condition with little indication of mortar loss; vegetation growth and seepage could result in the softening of the mortar, and eventual deterioration and loss of mortar from the exposed face.

Photo 20: Spillway (circled, high crested section) and Left non-overflow beyond.

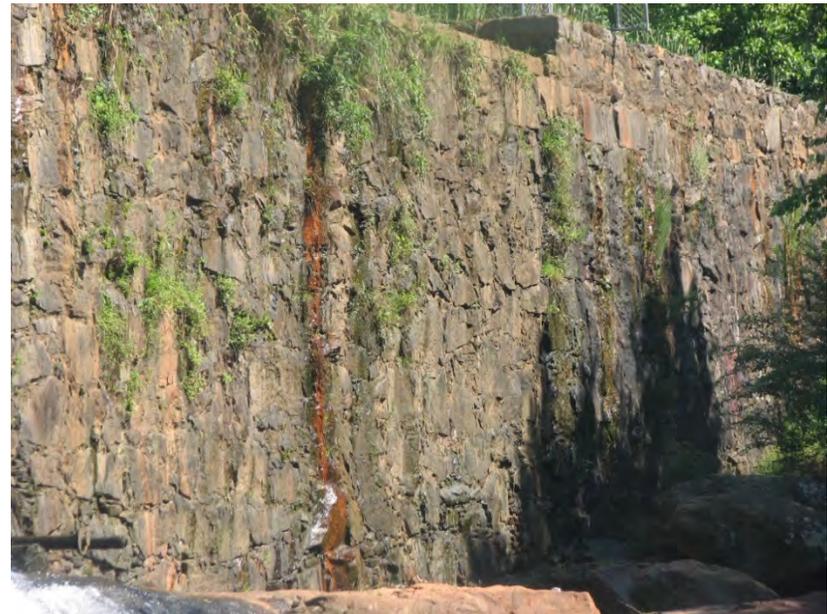
Photo 21: End of high crest spillway and start of left non-overflow.

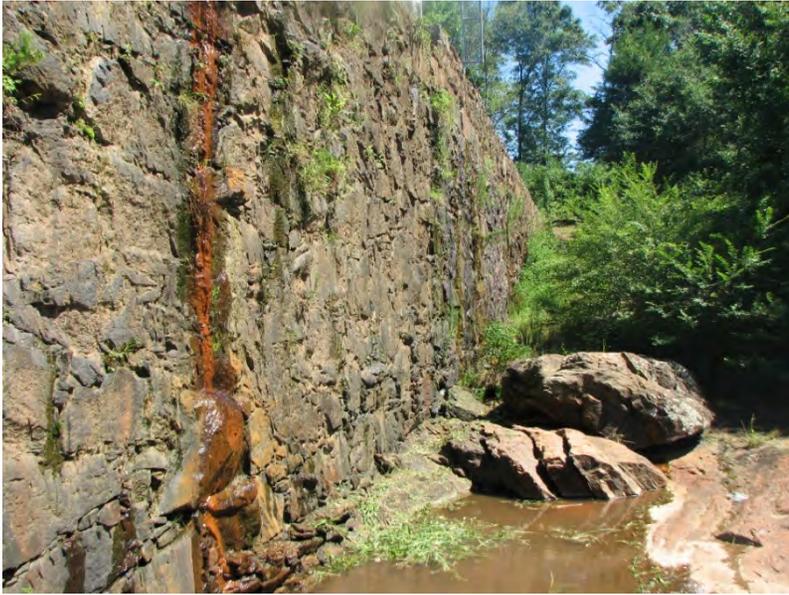
Photo 22: High crest section of spillway looking left.

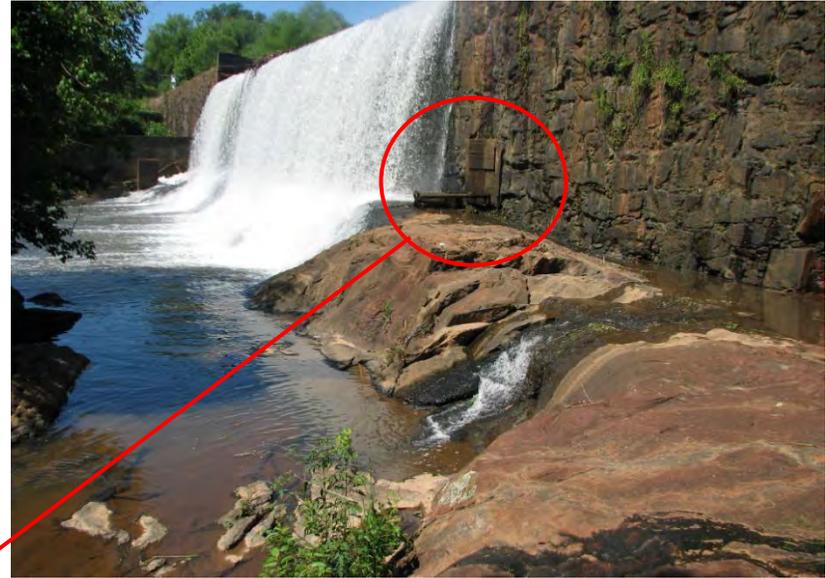
The foundation rock along the spillway toe appears sound and solid. The rock shelf on which the dam is founded (Photos 15 and 23) does not indicate that there has been any loss or displacement of foundation rock, nor is there any indication of historic or recent undermining of the dam having occurred. The exposed ridges and bedrock downstream of the spillway do not indicate that there has been any significant scour or erosion of the bedrock.

Photo 23: High crest section of spillway looking right, rock shelf along base of structure and plugged outlet gate.

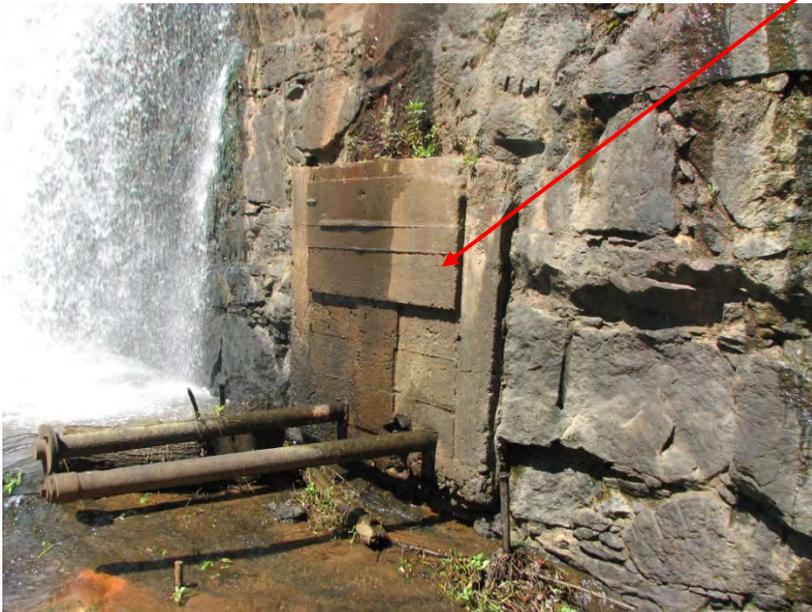
Photo 24: High crest section of spillway, plugged outlet gate.

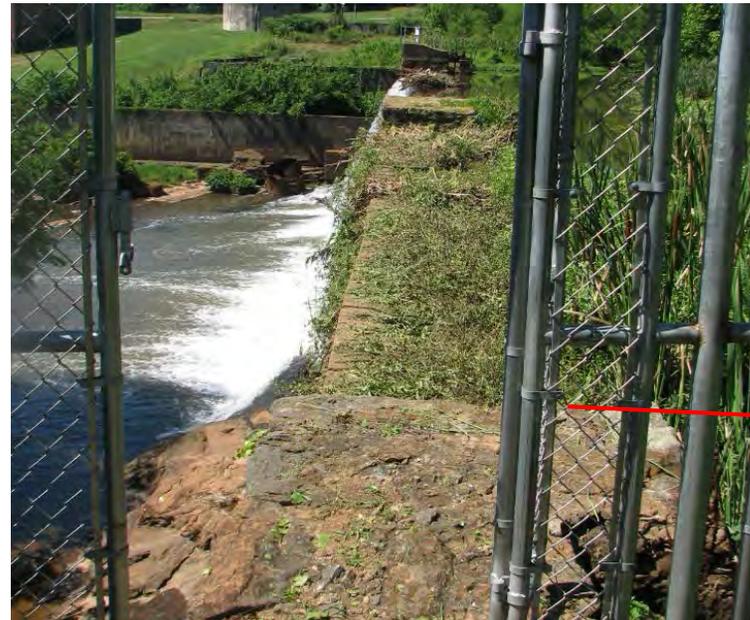
Photo 25: Looking right at dam spillway, high crest starting at red line.

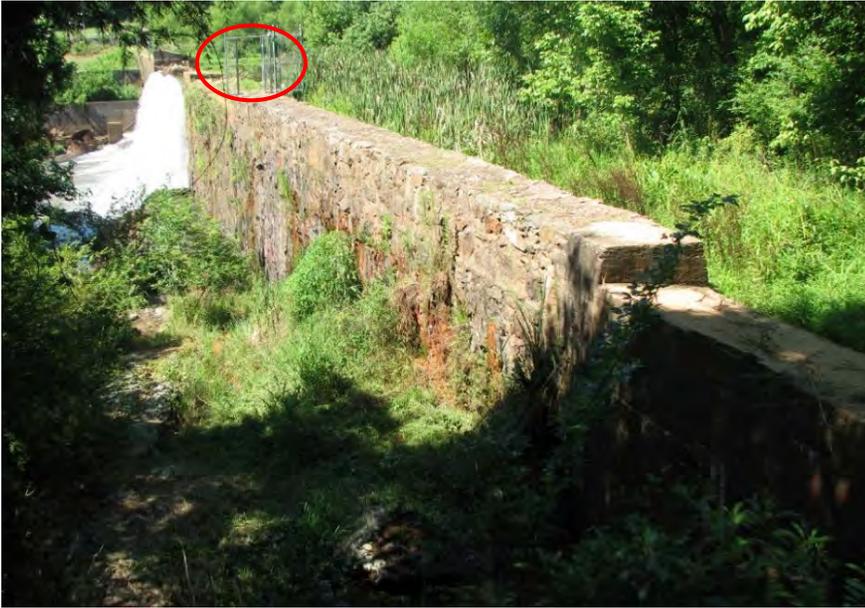
Photo 26: Left non-over flow with high crest spillway starting at fence (circled).

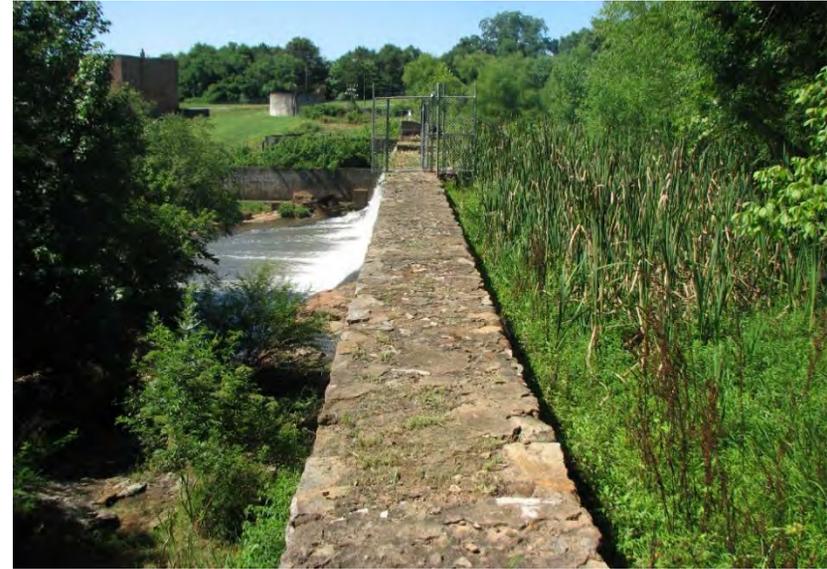
Based on visual observations, the structure appeared to be true to alignment and elevation, exhibiting no signs of movement or structural distress. There was no observed displacement or bulging of the stone masonry observed, including along the crest (Photo 27). There were no anchorages observed indicating that flashboards had been installed on the LNO. There was no structural cracking observed, nor cracking that could be associated with movement. There is no indication of overturning or sliding of the structure nor is there any sign of displacement of any of the stone masonry. Mortar joints are tight with little indication of mortar loss; there is some mortar deterioration (softening) ongoing where seepage and vegetation are the heaviest, conditions could result in the greater deterioration and loss of mortar from the exposed face.

Photo 27: Left non-overflow crest; note high cattails on upstream side.

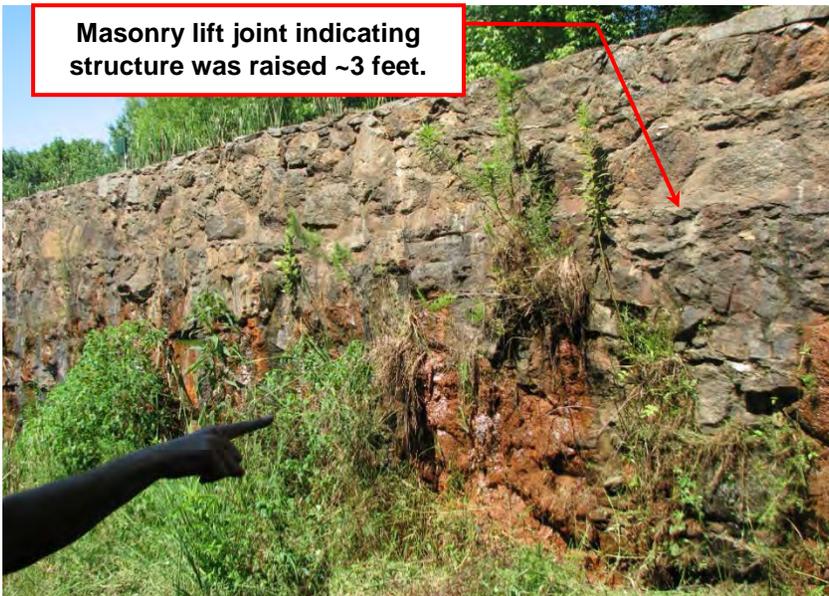
Seepage through the masonry is occurring, and it is worse at the LNO than at any other part of the dam. At the time of the inspection, the impoundment was approximately 3 feet below the crest of the LNO structure and sediment and vegetation on the upstream side of the structure was 2 to 3 feet below the crest (Photo 27). The base of the structure is founded on exposed bedrock, there was no indication of seepage or leakage occurring along the base of the structure.

Photo 28: Left Non-Overflow Structure, seepage through dam.
